Evaluation of the Tekscan F-SCAN system for measurement of the kicking force in horses

A. Fürst¹, L. D. Galuppo², C. E. Judy³, J. Auer¹, J. R. Snyder²

¹Equine Department of the Vetsuisse Faculty, University of Zurich, Switzerland, ²Department of Surgical and Radiological Sciences and the ³Veterinary Medical Teaching Hospital, School of Veterinary Medicine, University of California, Davis, USA

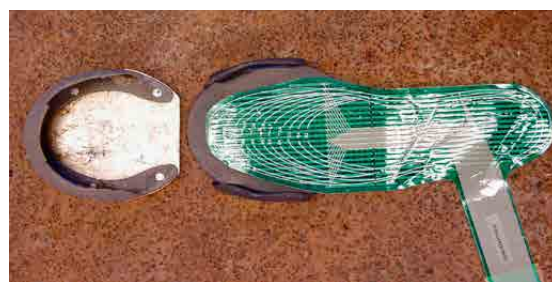
Fig. 1: Tekscan F-SCAN and the horseshoe system prepared for measuring the force of a kick.

The Tekscan F-SCAN system is an in-shoe pressure measuring system that has been used primarily for gait analysis on treadmills in human kinetics. It uses ultra-thin plastic sensors in the shape of a human foot. Each sensor contains 960 piezoelectric elements composed of quartz crystals, which generate an electric current when deformed. The amplitude of the electric current is proportional to the force applied to the sensors and can be amplified and displayed on a computer. Piezoelectric measuring systems are very sensitive over a wide range of forces and also can be used to measure the heart rate of a standing person or the impact on a dummy during

an automobile crash (McLaughlin et al., 1996; Young, 1993). Only the front part of the sensor (from the toe to the arch of the foot) was used to record the force of a kick because this region fits the sole of the hoof. Each sensor was placed between two 2-mm plastic pads, which were incorporated into a custom-made horseshoe (Fig. 1). A sensor-shoe combination was attached to each hind foot to measure the force of the kicking limb and the stance phase of the non-kicking limb (Fig. 2). The sensors were connected to a converter, which was fastened to the fetlock with Velcro. The measuring system was connected via a 10-m cable and a 16-bit receiver card to a microcomputer with the corresponding pressure and force measurement software program. To obtain meaningful measurements, the Tekscan sensors must be calibrated to the anticipated pressure range (Brimacombe et al., 2009). Therefore, before obtaining any force measurements, each sensor was individually calibrated with the previously recorded weight borne by the hind limbs with the horse standing square.

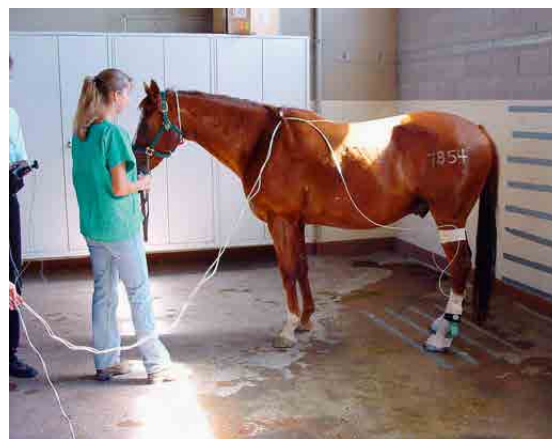
Fig. 3: The horse is placed with its hind end toward a cement wall.

All horses were restrained using a halter and lead shank and placed with their hind end towards a cement wall. The distance between the wall and the back hooves was 40 to 50 cm, depending on the length of the hind legs of each horse, to make sure that the horse did not miss the wall when kicking. Strips of tape were placed 20 cm apart on both the floor and the wall so that the distance between the horse and the wall and the site of contact between the hoof and the wall could be determined (Fig. 3). This was achieved by recording each kicking event with a video camera. All kicks were evaluated subjectively based on the speed and severity of the kick and the noise created by the impact of the foot against the cement wall and graded on a scale from 1 (weak) to 5 (very strong).
